Published in:
Eco-Architecture VI

Architectural qualities of Danish office buildings built between 1960 and 1980, seen in a contemporary sustainable perspective

L. Hannoudi¹, M. Lauring¹, J. Christensen²

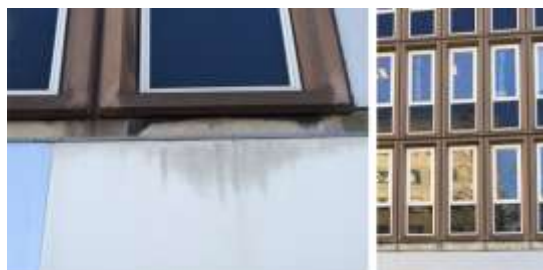
Figure 5: Problems like mould in the façade.

There was a great need for industrialized building components for the construction of office buildings in the sixties and the seventies due to the large demand for office buildings in that period. There were many economic benefits and time savings with this new system, but there were also many characteristic problems that faced the office buildings later on, such as cracks in the concrete carbonates and corrosion of the reinforcements. Some parts of the facades faced problems like mould and fungus, and there were problems with sealing materials (A. Dragheim) [8].

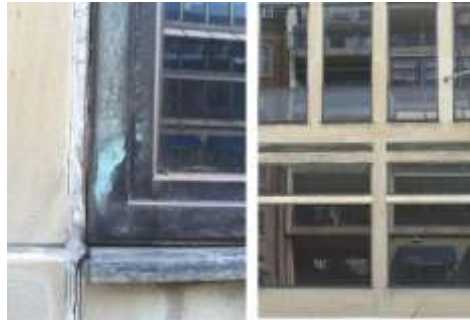
Figure 6: Problems in sealing materials in some parts of the facades.
